PIPELINE METALLURGICAL FAILURE ANALYSIS

16TAN LICENSE 802177-001

Husky Energy Inc.

October 24, 2016
Acuren Project No.: 306-0087829-1-R1

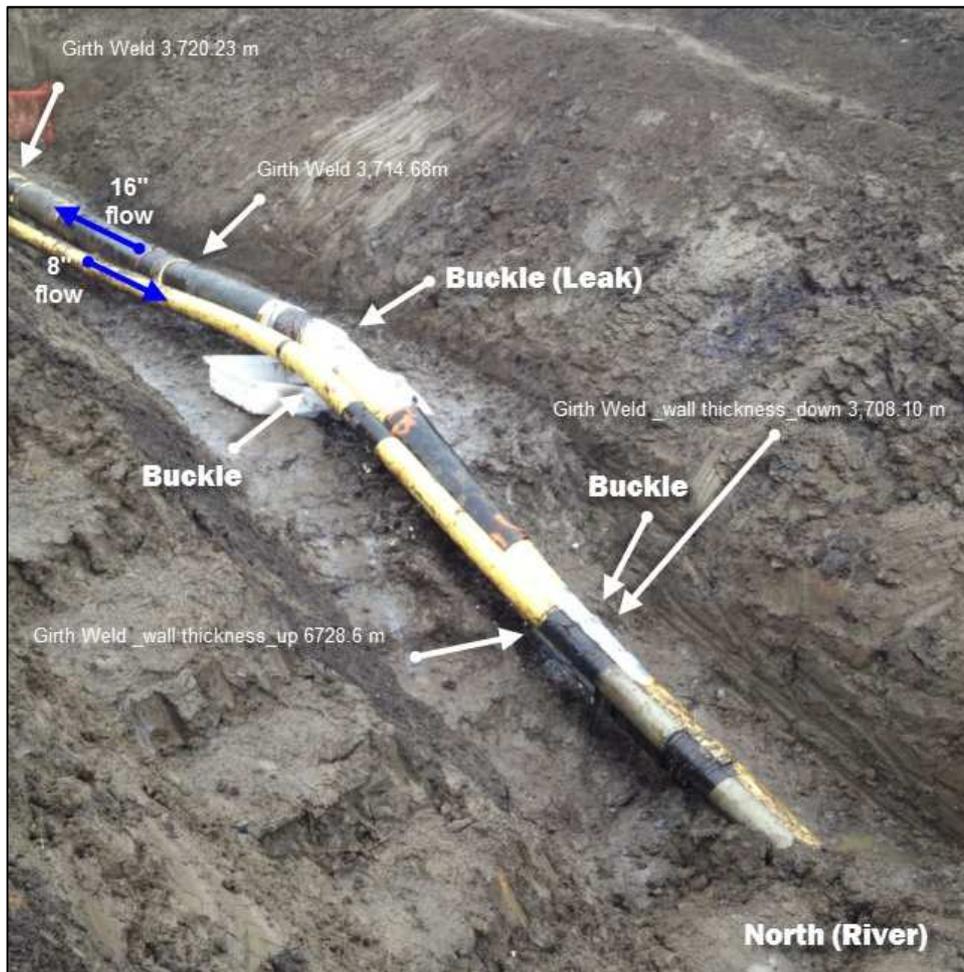
Figures 2 and 3 are site photographs taken at the time of excavation of the failed pipeline, prior to removal of the failure segment. As noted, the leak site was found to be associated with buckling deformation in the pipe and there was a second buckled location found in this line immediately upstream of the leak site. Also noted in Figure 2, there was a nominal 219.1 mm OD condensate line adjacent to the 16TAN line in the same right-of-way and this condensate line also exhibited buckling deformation at approximately the same location as the buckled leak site in the 16TAN line. Samples were also cut from the non-failed buckled locations of these two pipelines and submitted to Acuren for examination and testing. The results of this work have been addressed in a supplemental Acuren report to Husky Energy.

FIGURE 2 OVERVIEW OF EXCAVATED PIPELINES SHOWING BUCKLED LOCATIONS AND LEAK SITE

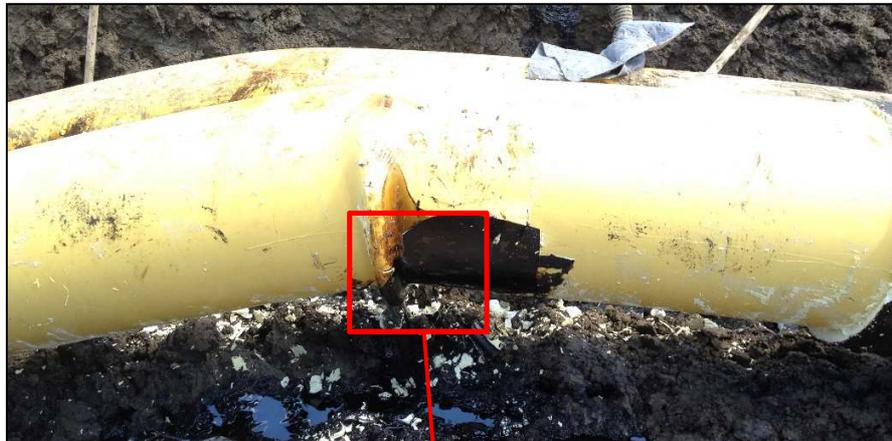
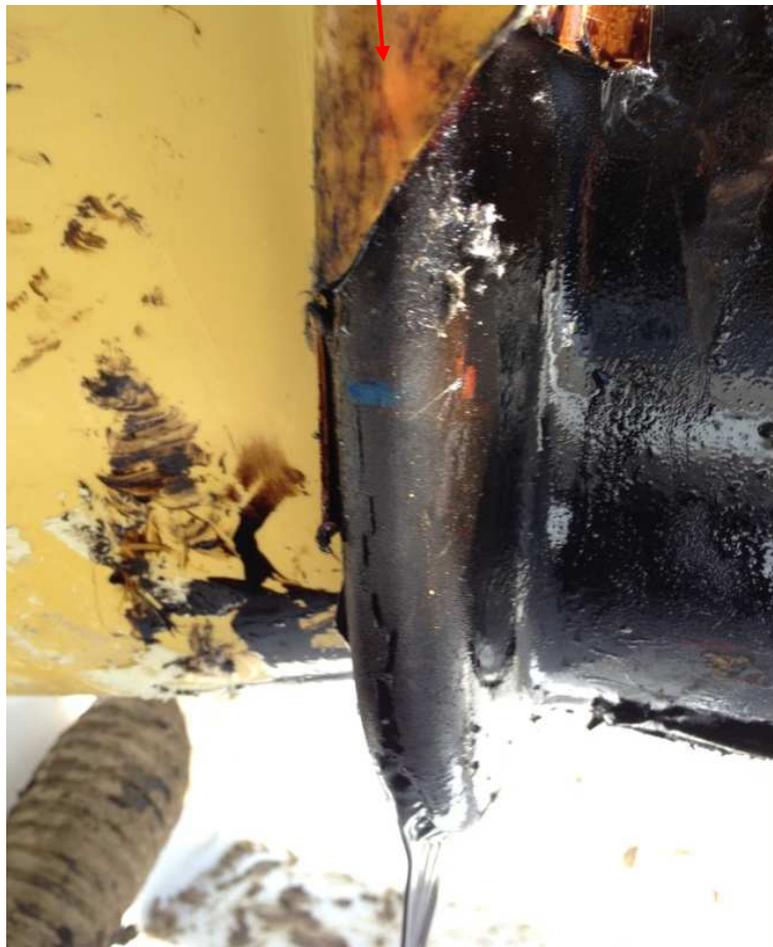
FIGURE 3 **BUCKLING DEFORMATION AT 16TAN LEAK SITE**

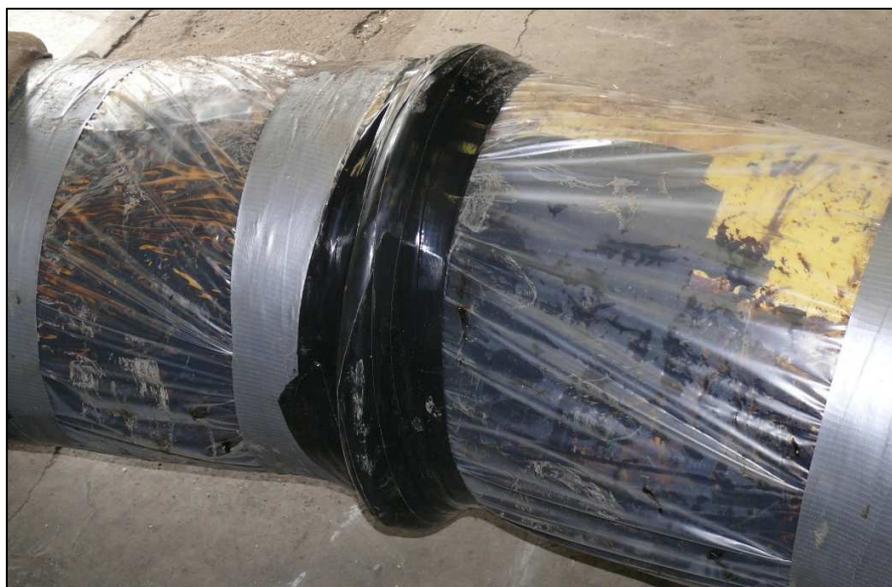
Figure 4 shows the as-received appearance of the buckled leak location at approximately mid-length on the supplied pipe sample after removal of the pipe from its steel shipping frame. As can be seen, the failure zone had been wrapped with clear plastic, held in place with duct tape. Black polyethylene tape had then been wrapped over the plastic sheet over top of the buckled zone. The foam insulation and outer polyethylene coating had been removed from this sample prior to shipment to Acuren.

FIGURE 4 AS-RECEIVED TAPE AND PLASTIC WRAPPING ON FAILED BUCKLE ZONE

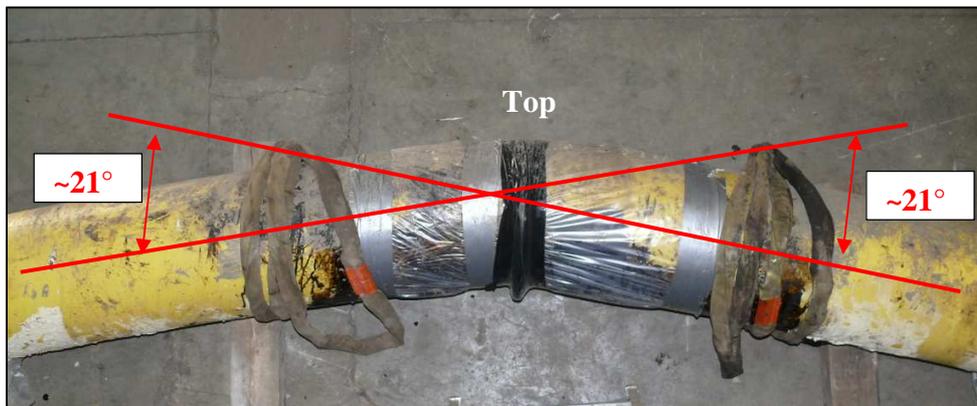
The pipe sample consisted of two relatively straight segments with an inflection point coincident with the pronounced buckling at the leak location. Figure 5 shows a side view of the as-received failed pipe sample and illustrates the approximately 21° deflection angle in the vertical downward direction in the pipe, centred on the buckle.

FIGURE 5 BEND ANGLE ON PIPE PROFILE

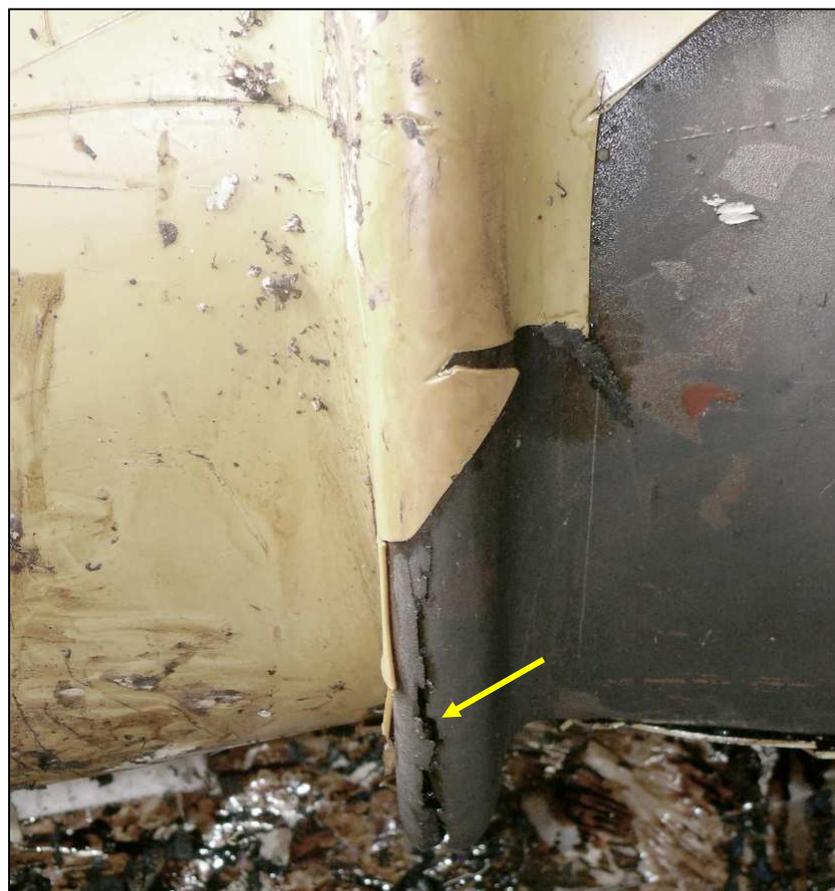
The tape and plastic wrap were removed from the failure zone and Varsol was used to remove the oily residue on the OD surface of the pipe. Figure 6 shows the buckled and fractured failure region of the pipe after Varsol cleaning. As shown previously in Figure 3, a portion of the Yellow Jacket on one side of the buckle had been removed from the pipe on site prior to shipment to Acuren. Visual examination of the exposed external steel surface did not reveal any evidence of corrosion damage.

FIGURE 6 BUCKLE AND THROUGH-WALL FRACTURE AFTER CLEANING OD SURFACE WITH VARSOL

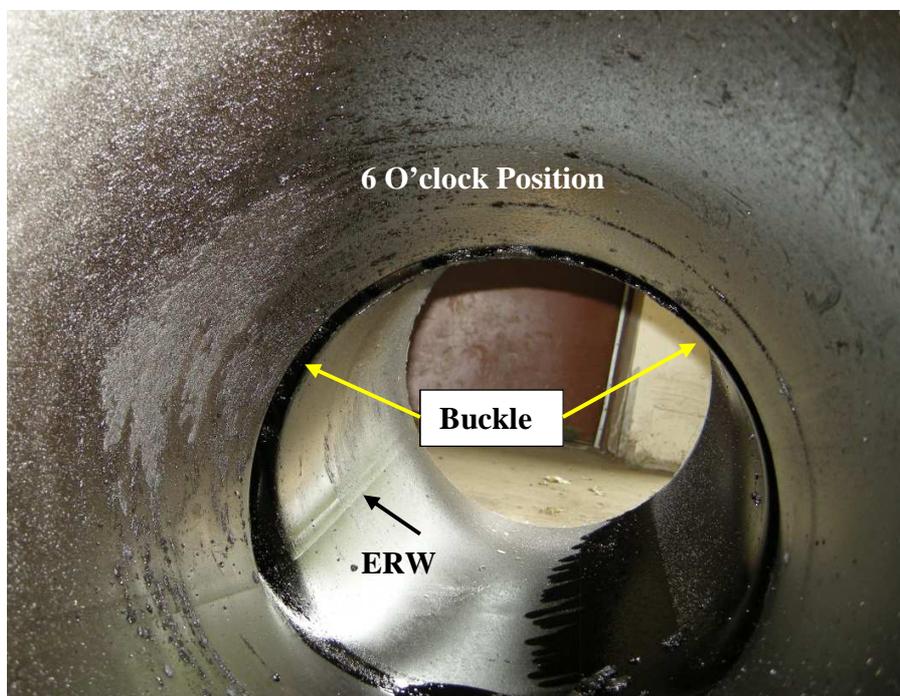
As noted previously, the external surface of the pipe, including the buckled zone, did not exhibit any evidence of corrosion damage. The ID surface of the as-received pipe was covered with oily hydrocarbons, as shown by example in Figure 7. The ERW seam was located just above the 9 o'clock position (i.e. approx. 10 o'clock), near one end of the circumferential buckle. The buckle extended around about 50% of the circumference, centred at approximately the 6 o'clock position. The through-wall fracture at the apex of the buckle was also centred at the 6 o'clock position and extended around about 30% of the circumference (approx. 380 mm fracture length).

FIGURE 7 OILY FILM ON AS-RECEIVED ID SURFACE AS VIEWED FROM DOWNSTREAM END

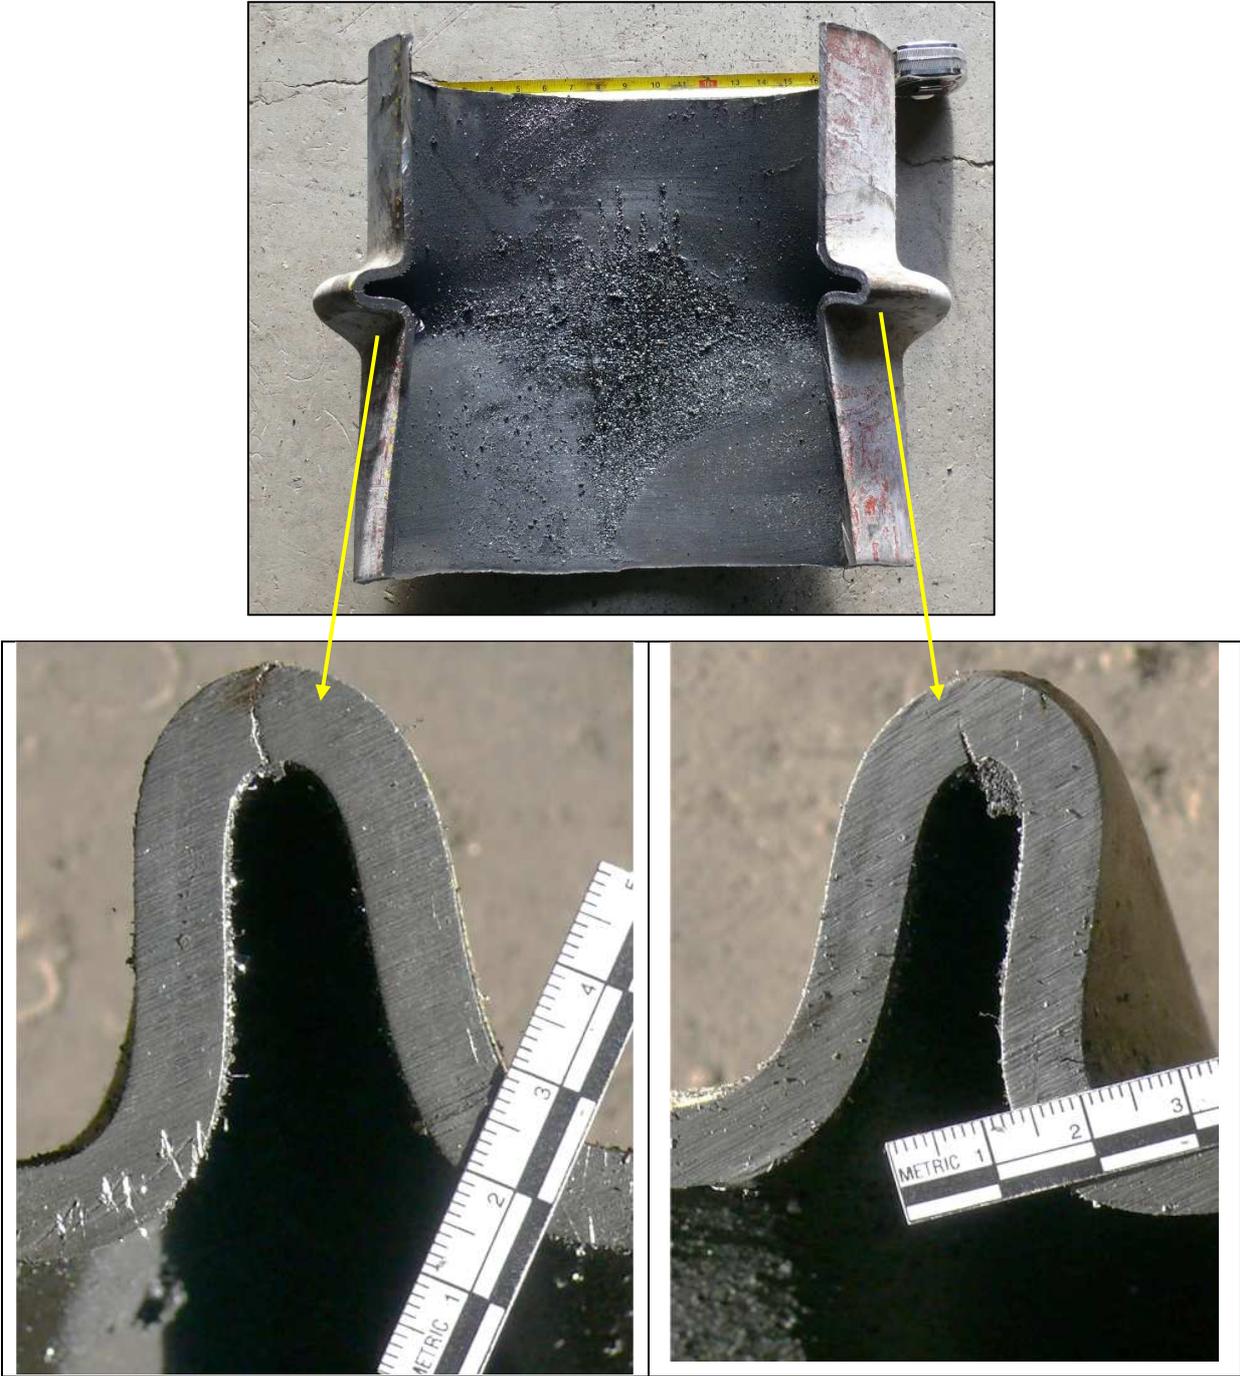
Figure 10 shows the remainder of the failed pipe segment after removal of the fracture zone, including close-up views of the saw cut buckled profile at each end of the through-wall fracture. As can be seen, the ID surface at the apex of this bulge on either side of the through-wall fracture exhibited a relatively deep crack. This cracking was an extension of the through-wall fracture.

FIGURE 10 BUCKLE PROFILE AT SAW CUT FRACTURE ENDS OF INTACT SEGMENT

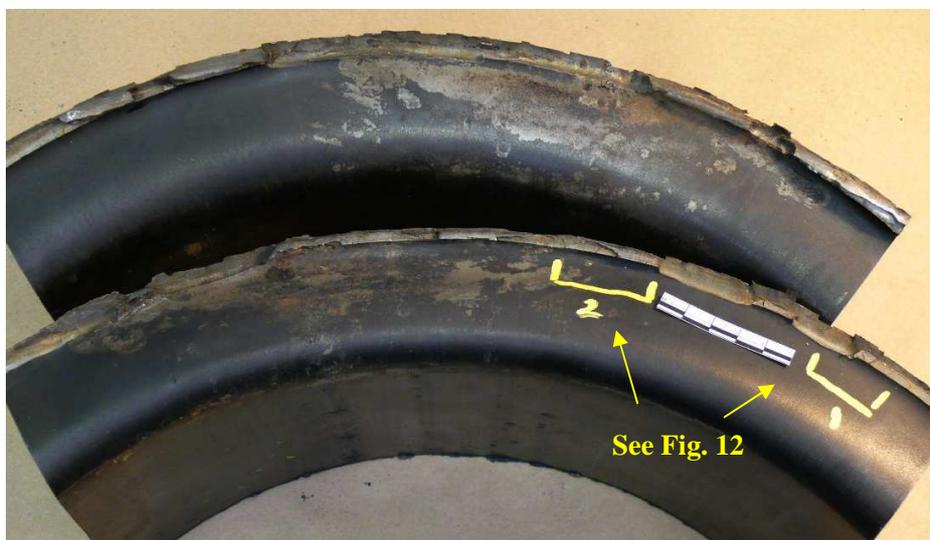
The internal surface of the extracted buckled and fractured pipe segment was washed with Varsol to remove the black oily deposits and permit a more detailed visual examination of the fracture faces. This examination revealed two distinct fracture zones: Several areas along the inner edge of the fracture exhibited a brittle planar fracture morphology, with evidence of small step-like ratchet marks. The remainder of the fracture was predominantly ductile in appearance, exhibiting a dull satiny finish with a slanted or curved fracture profile. There was no evidence of a difference in colour or scale build-up between the inner brittle zones and the outer ductile zones.

Based on the observed fracture features, two locations were selected as being representative of the typical fracture features present along the full length of the fracture. The locations of these two locations (numbered 1 and 2) are shown in Figure 11, while Figure 12 shows these two fracture zones in detail. These fracture locations were subsequently cut out for detailed examination by scanning electron microscopy (SEM) followed by metallographic examination, as described later in this report.

FIGURE 11 **DEGREASED FRACTURE SURFACES**

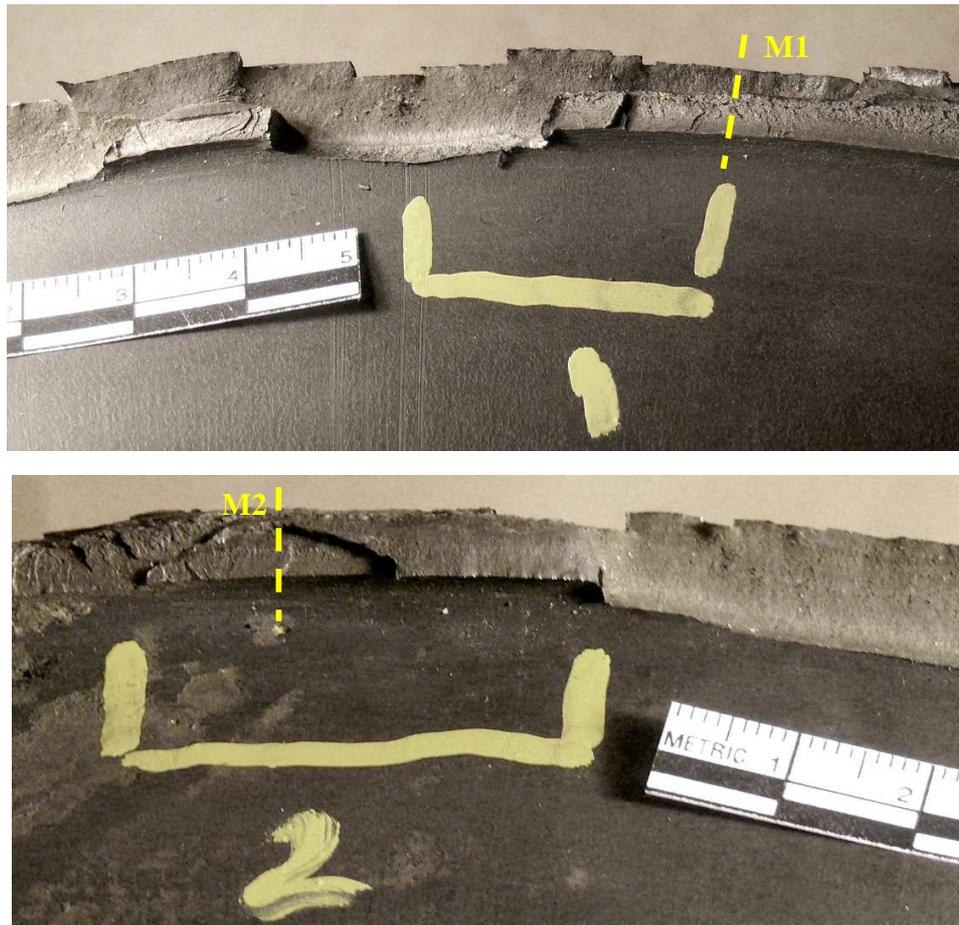
FIGURE 12 CLOSE-UP VIEWS OF FRACTURE ZONES SELECTED FOR SEM EXAMINATION

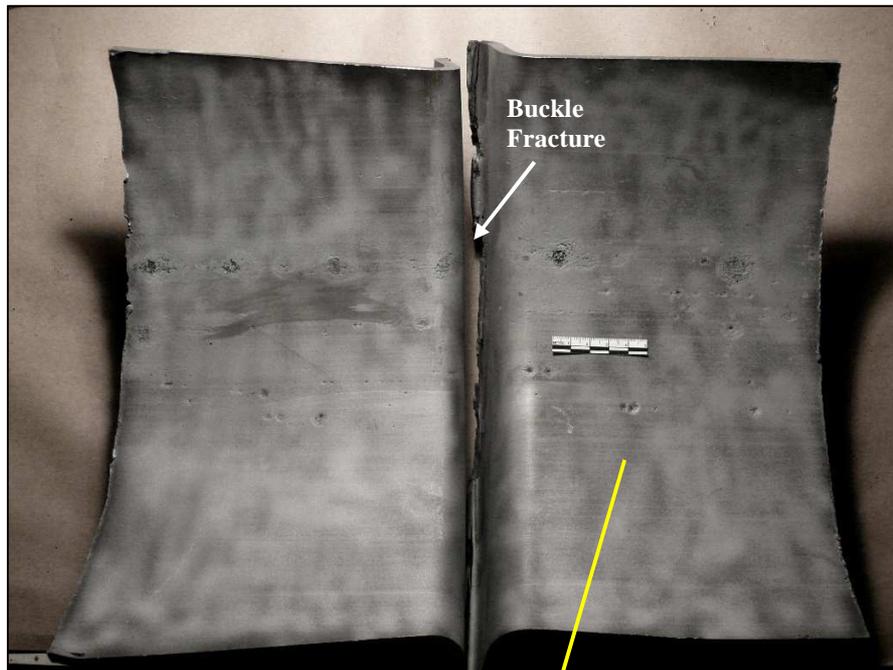
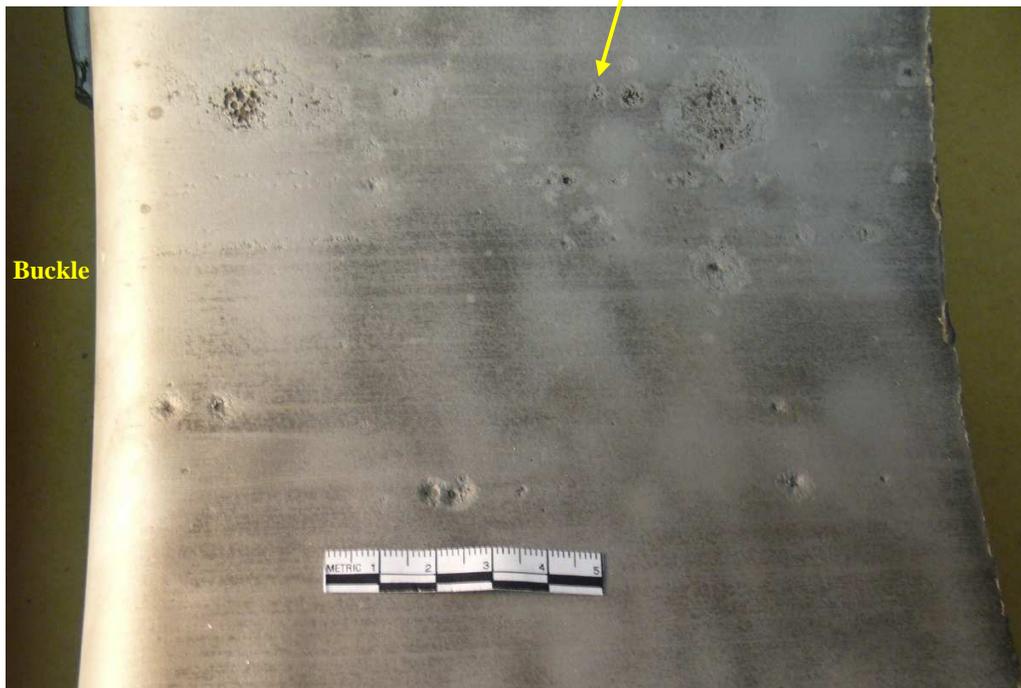
The internal surface of the buckled and fractured pipe segment was lightly sandblasted to remove the thin film of black scale. As shown in Figure 13, the sandblasted surface revealed a number of randomly distributed shallow corrosion pits within an approximately 150 mm wide axial band along the bottom quadrant of the line. These pits were very shallow, exhibiting depths that were estimated to be no more than about 0.2 mm. A few of these pits were also present within the buckled zone, in close proximity to the fracture. However, the fracture did not appear to have been influenced in any way by this localized corrosion.

FIGURE 13 PITTING ON SANDBLASTED BOTTOM QUADRANT

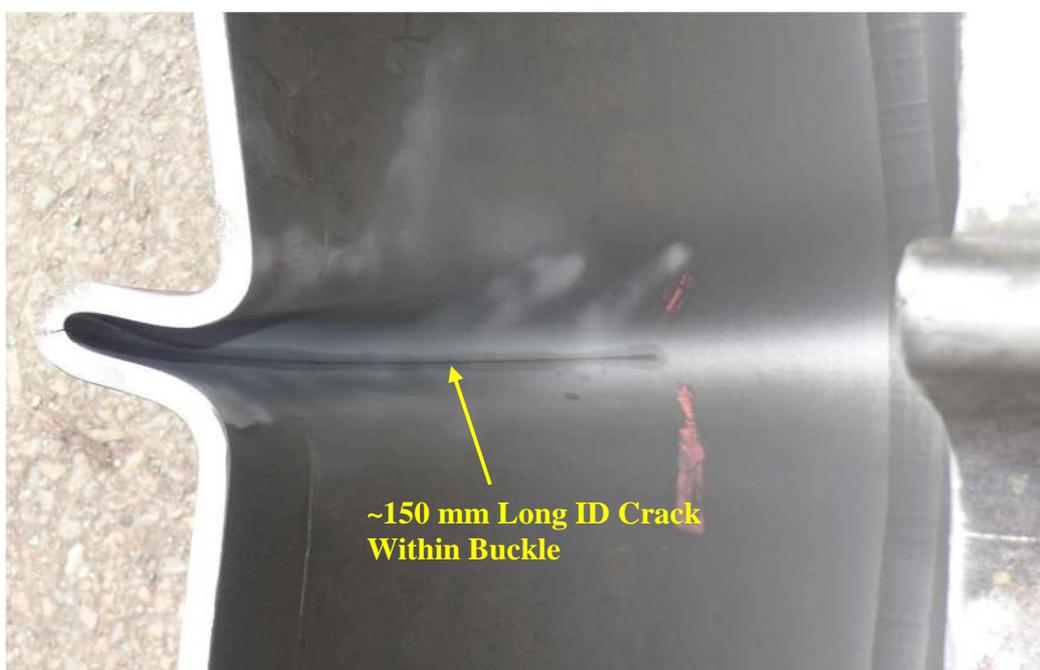
Inspection of the ID surface of the pipe on either side of the through-wall fracture zone revealed a single linear crack following the internal surface at the apex of the buckle, which extended for a distance of about 150 mm on either side of the through-wall fracture zone. Figure 14 shows this internal cracking on one side of the through-wall fracture zone for illustration purposes. This cracking did not extend through the pipe wall to the outside surface.

FIGURE 14 INTERNAL CRACKING WITHIN APEX OF THE ENDS OF THE BUCKLE ON EITHER SIDE OF FRACTURE ZONE

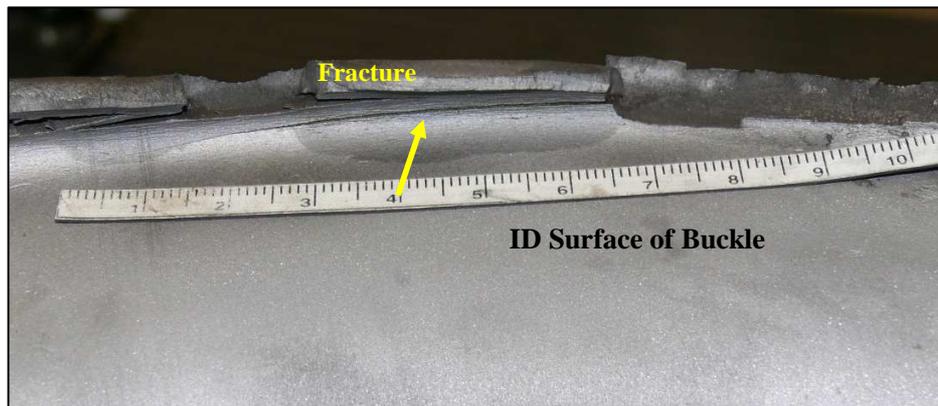
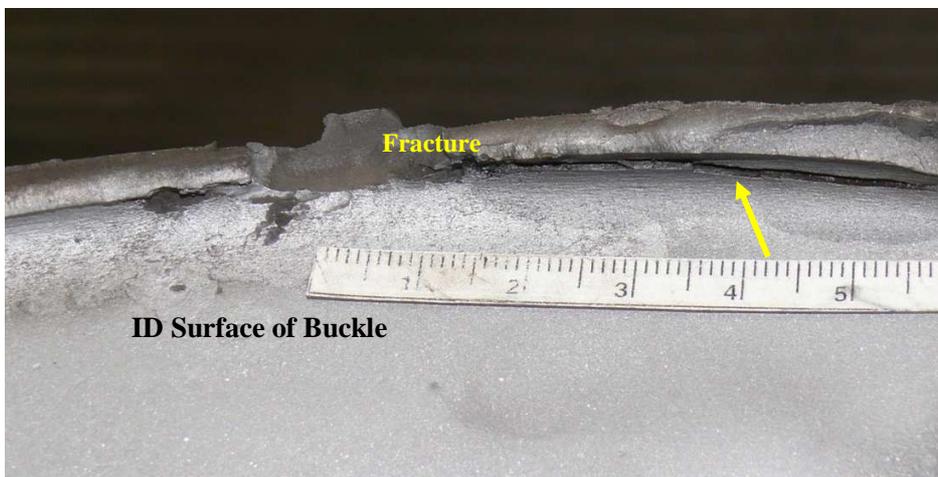
Figure 15 shows the brittle secondary cracking that was observed on the internal surface, parallel to and immediately adjacent to the main fracture within the apex of the buckle. As can be seen, this cracking was readily visible to the naked eye. This internal secondary cracking did not extend through the pipe wall to the OD surface.

FIGURE 15 **SECONDARY INTERNAL CRACKING ADJACENT TO FRACTURE**

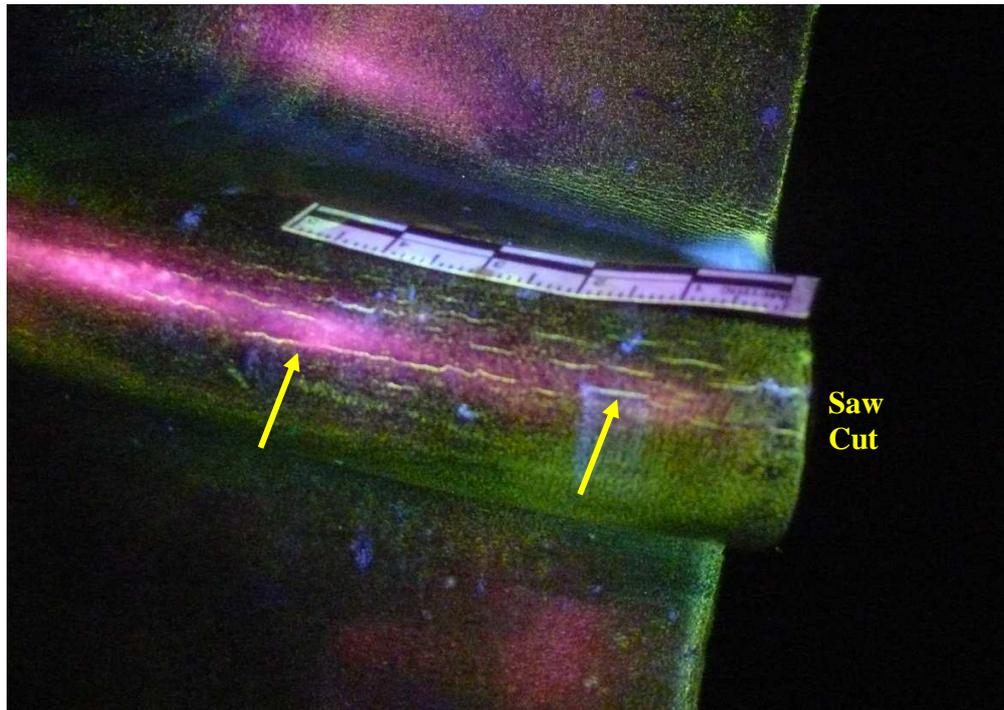
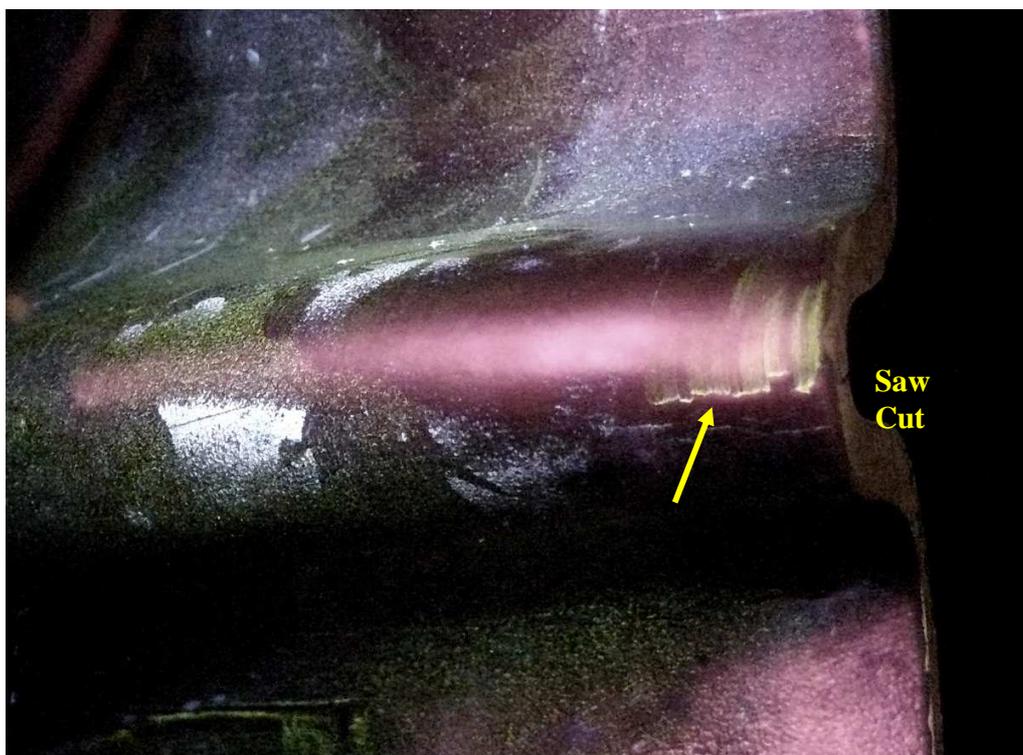
The only cracking detected on the external surface of the remainder of the failed pipe segment was at the apex of the buckle immediately adjacent to the saw cut edges, as shown in Figure 16. The MPI indication in the lower image of this figure appear to be an extension of the end of the through wall fracture, while the small intermittent indications in the upper image appear to be small surface tears.

FIGURE 16 ENDS OF EXTERNAL CRACKING AT APEX OF BUCKLE

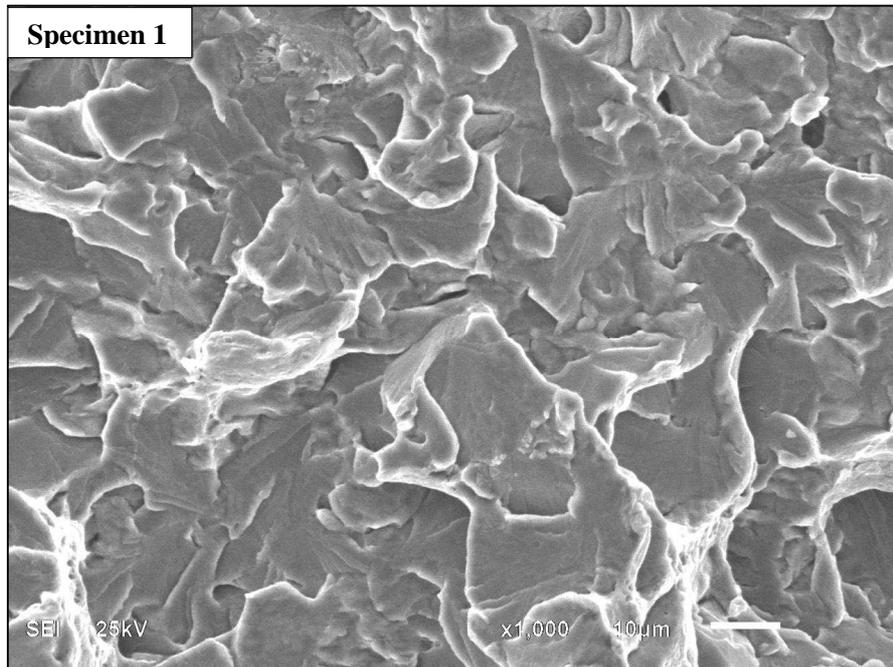
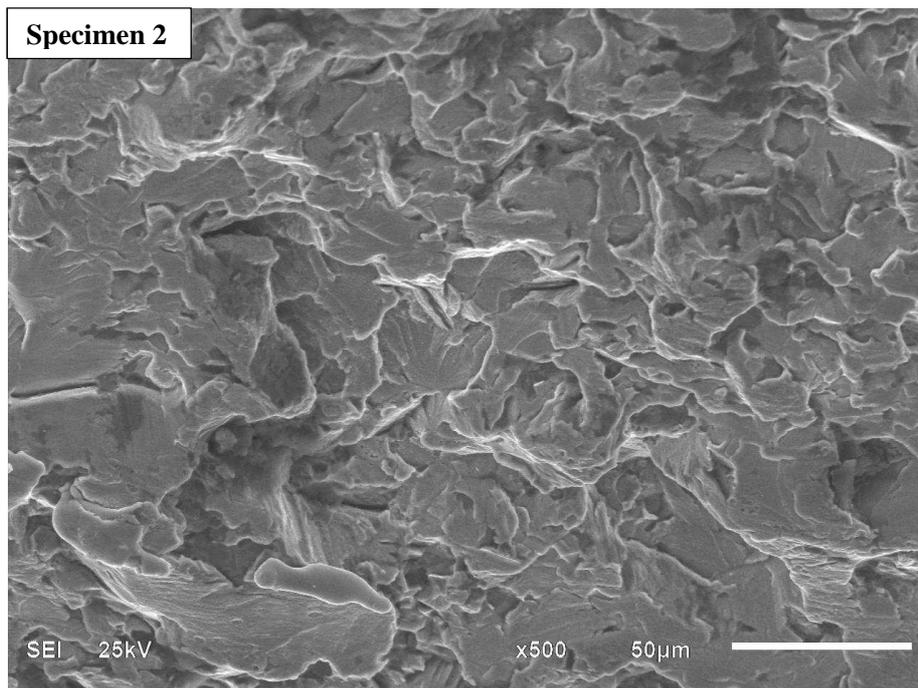
Examinations of the planar fracture regions near the internal surface of the pipe for both Specimens 1 and 2 revealed a brittle cleavage morphology, as shown by example with the SEM images in Figure 18. These brittle cleavage zones were found to transition to a more ductile morphology towards the external surface of the pipe. The SEM images in Figure 19 show examples of the ductile fracture morphology observed in these outer regions of the fracture on both specimens. There was no evidence of striation marks or other features associated with fatigue cracking found on either specimen.

FIGURE 18 EXAMPLES OF BRITTLE CLEAVAGE FRACTURE NEAR ID SURFACE

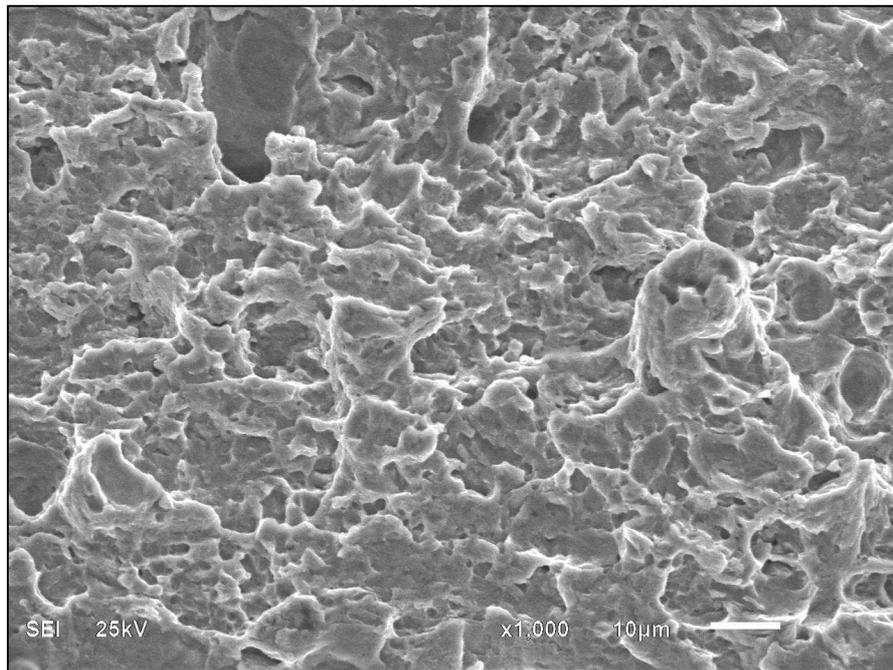
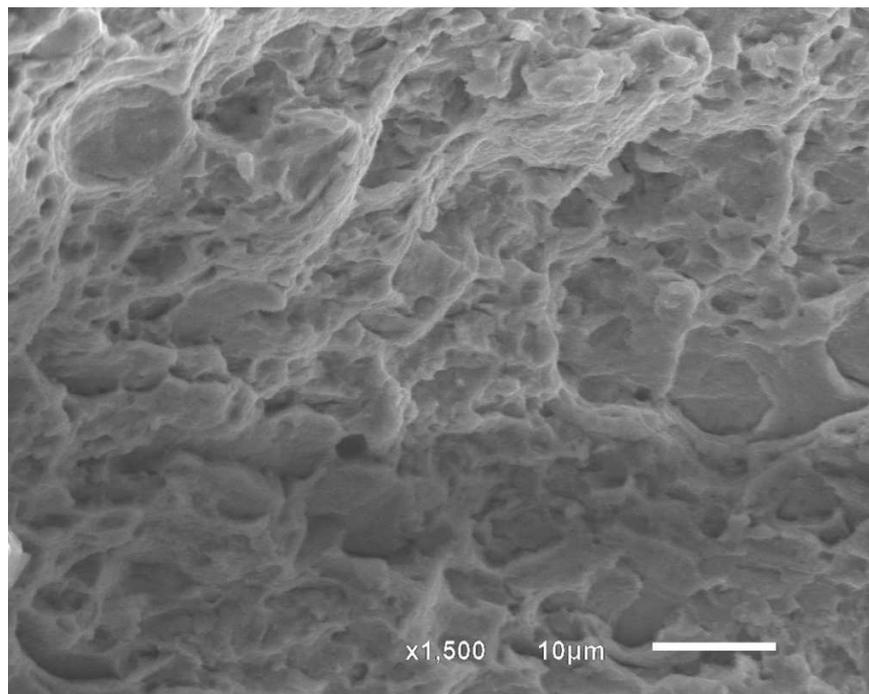
FIGURE 19 **EXAMPLES OF DUCTILE FRACTURE NEAR OD SURFACE**

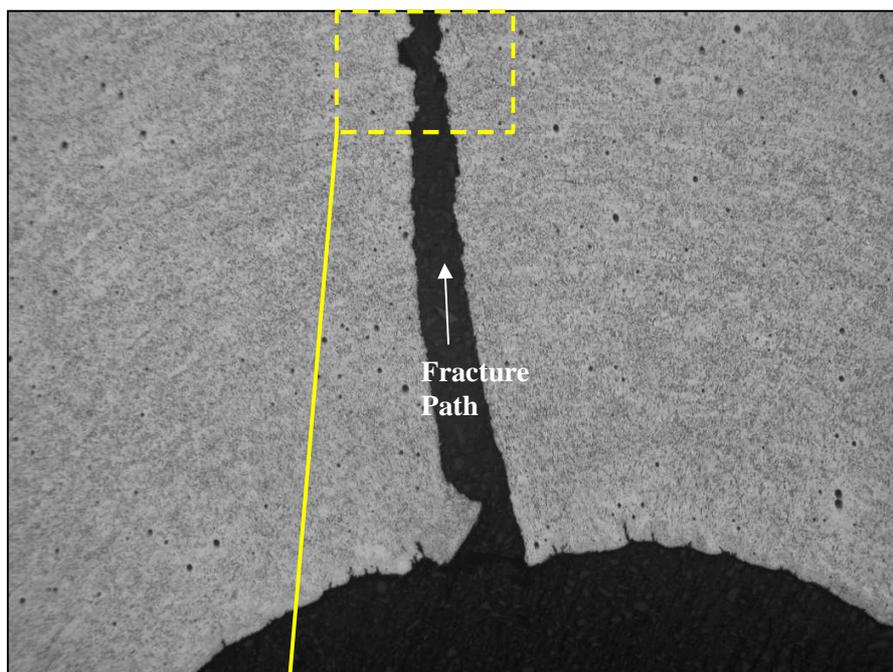
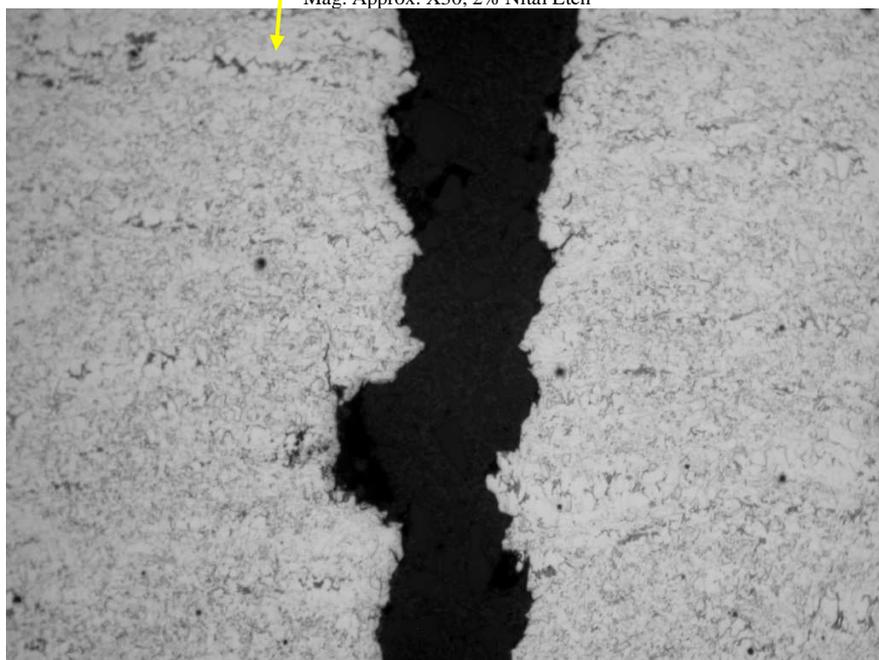
Figure 21 shows the brittle fracture profile near the inner surface at the apex of the buckle for specimen M1, while Figure 22 shows the brittle fracture profile near the inner surface of M2. As noted in Figure 22, M2 exhibited a secondary brittle crack (approx. 1 mm deep) adjacent to the main through-wall fracture. As shown in the higher magnification photomicrographs in Figure 23, both M1 and M2 exhibited a very fine-grained ferritic microstructure with small localized colonies of pearlite, as is typical of control-rolled line pipe product. The inner surface of the apex of the buckle in both specimens exhibited small crease-like folds, as a result of the plastic deformation which took place when the buckle was formed. As shown in the photomicrographs in Figure 24, the outer portions of the through-wall fracture in M1 and M2 exhibited plastic grain deformation along the fracture edges, indicative of a ductile shear fracture mechanism in this outer wall region. The metallographic observations described above are consistent with the findings of the SEM examinations.

FIGURE 21 BRITTLE FRACTURE PROFILE (M1)

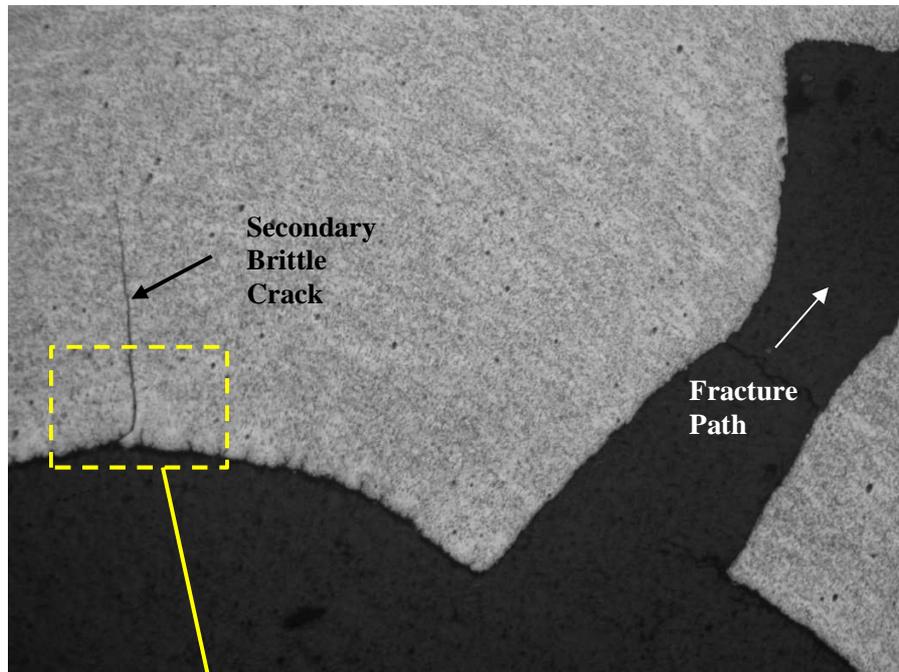
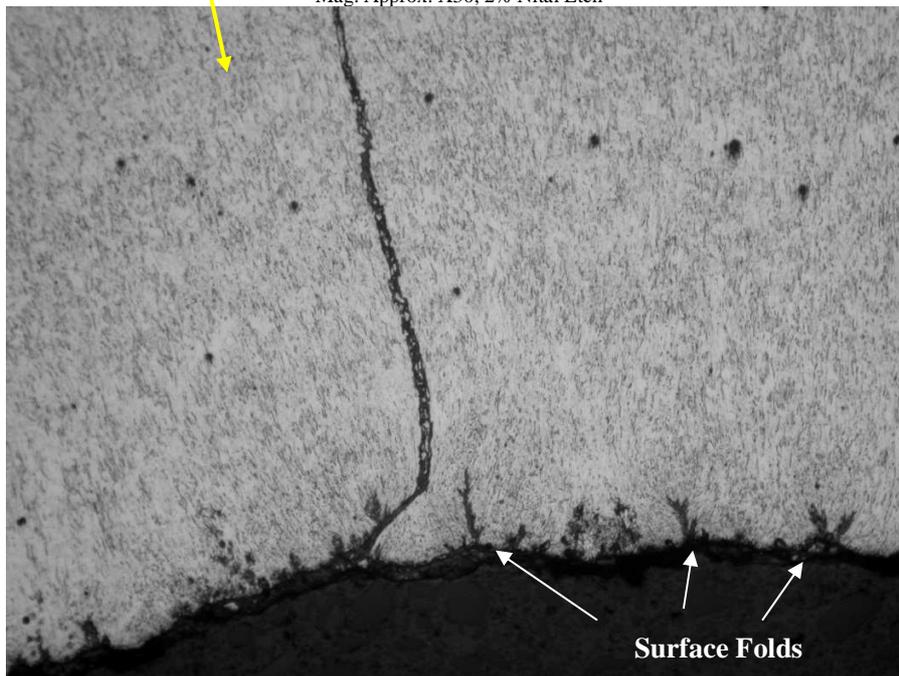
FIGURE 22 BRITTLE FRACTURE AT INSIDE SURFACE OF THE BUCKLE APEX OF M2

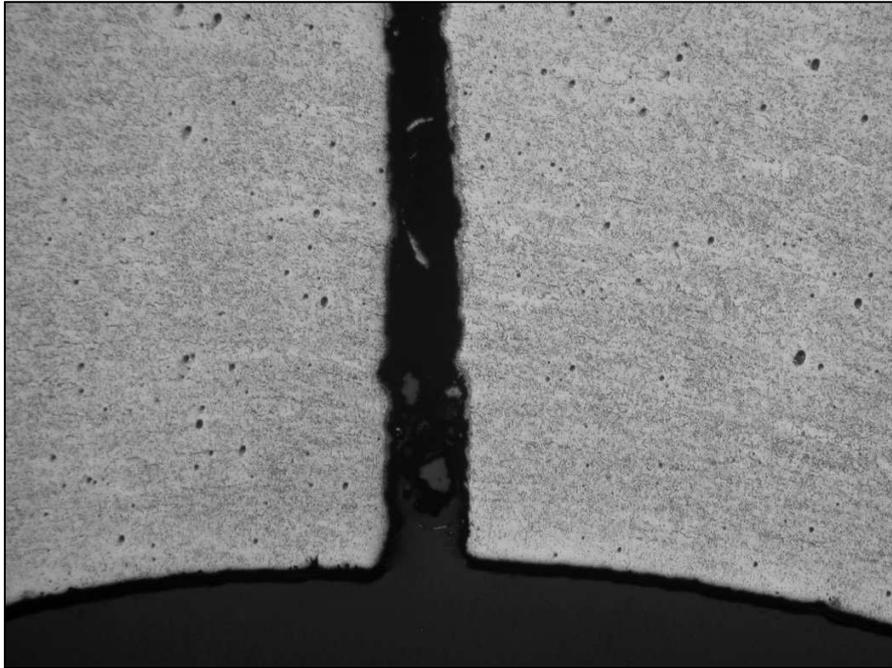
Figure 25 shows the crack initiation zone at the inner surface of the apex of the buckle in specimen M3, while Figure 26 is a higher magnification image taken at the tip of this brittle crack. The depth of the crack at this location was approximately 6 mm or 75% of the wall thickness. Figure 27 is a high magnification photomicrograph of the typical microstructure observed in the buckled region of M3. The microstructure and brittle crack morphology of M3 were similar to that observed for specimens M1 and M2.

**FIGURE 25 BRITTLE CRACK AT INSIDE SURFACE OF THE
BUCKLED APEX OF SPECIMEN M3**

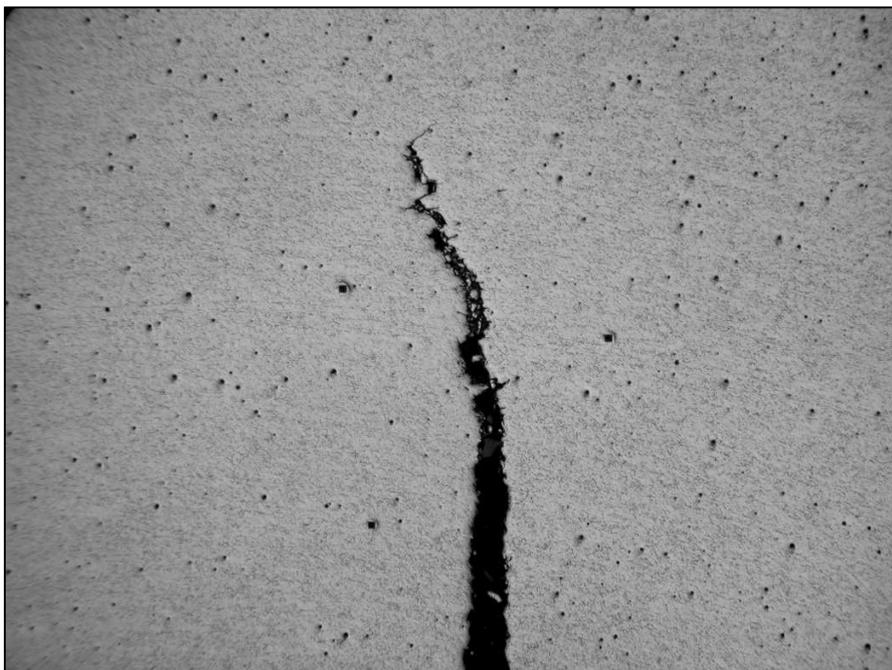
FIGURE 26 TIP OF BRITTLE CRACK IN M3

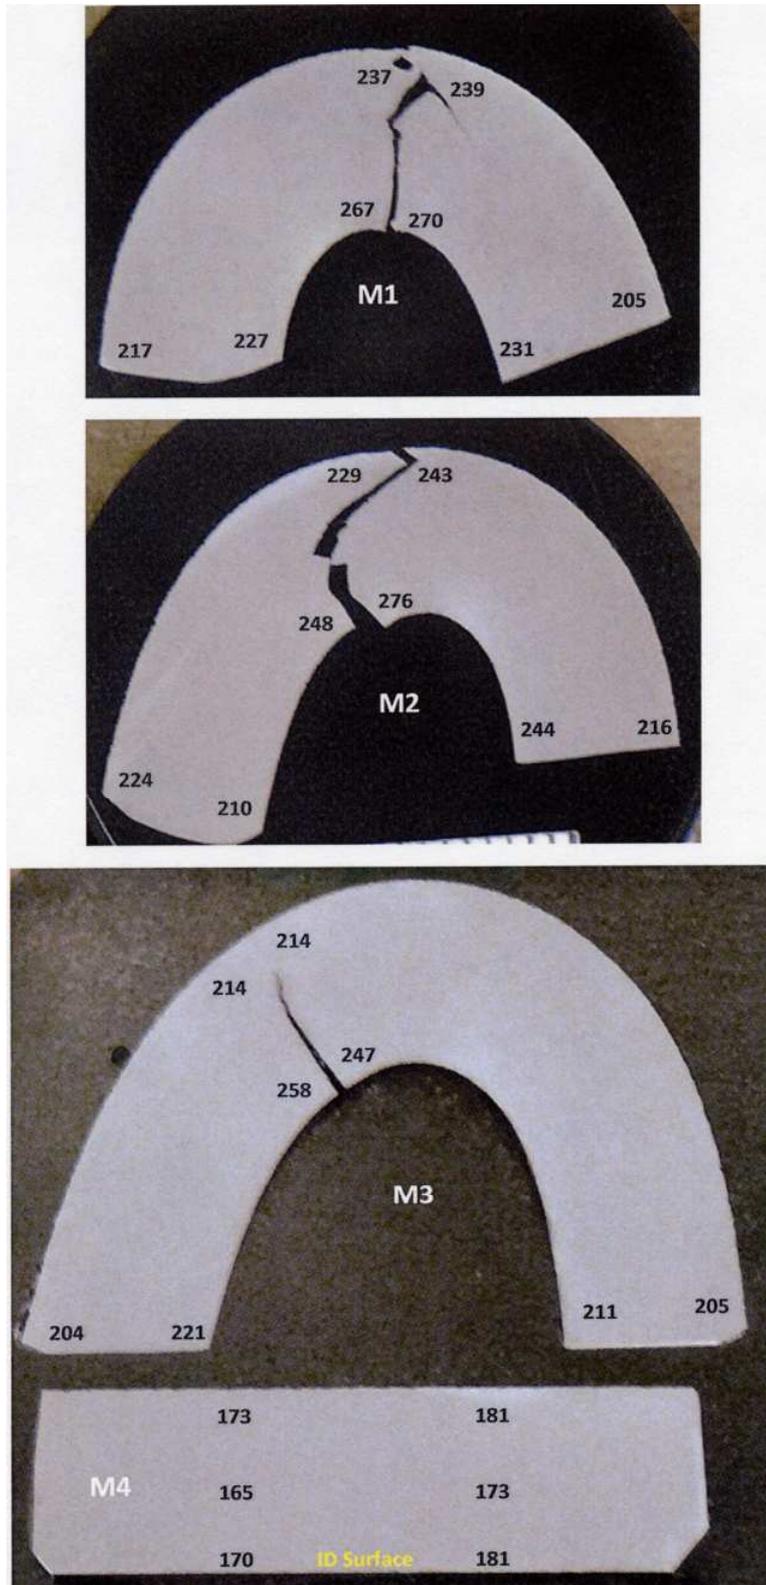
Vickers microhardness testing was performed on the polished surfaces of the four specimens using a 500g test load. The results of this testing are summarized in Figure 32. The original pipe hardness, represented by specimen M4, ranged from about 165 to 181 HV500gf, with the material near the surfaces being slightly harder than at mid-wall. These results are consistent with common line pipe material, such as CSA Gr. 359. As expected, the hardness within the buckled zone of all three specimens, particularly near the inner apex, was significantly higher than the M4 non-deformed pipe material, as a result of the work hardening generated by the severe plastic deformation introduced during the buckling event.

FIGURE 32 VICKERS MICROHARDNESS RESULTS (HV500GF)

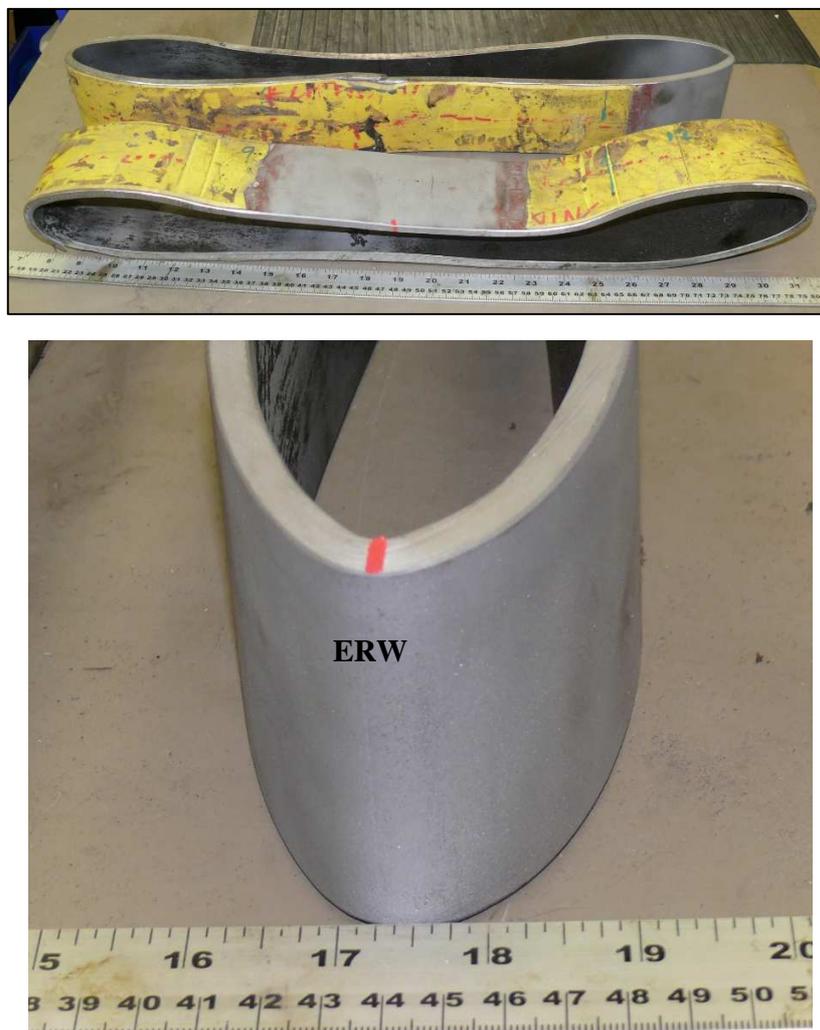
As requested, flattening test coupons were cut from the pipe just upstream of the buckled failure zone and tested in accordance with CSA Z245.1. The ERW seam in one coupon was aligned with the compression (i.e. flattening) direction, while the ERW seam in the second coupon was oriented at 90° to the compression direction. The pipe samples passed the CSA flattening test (i.e. compression to 50% of diameter) and were then further flattened until the diametrically opposite ID surfaces came in contact. There was no evidence of cracking observed after this complete flattening process. Figure 33 shows the final flattened test coupons and the absence of cracking.

FIGURE 33 RESULTS OF FLATTENING TESTS
