PIPELINE METALLURGICAL FAILURE ANALYSIS

16TAN LICENSE 802177-001

Husky Energy Inc.

October 24, 2016
Acuren Project No.: 306-0087829-1-R1

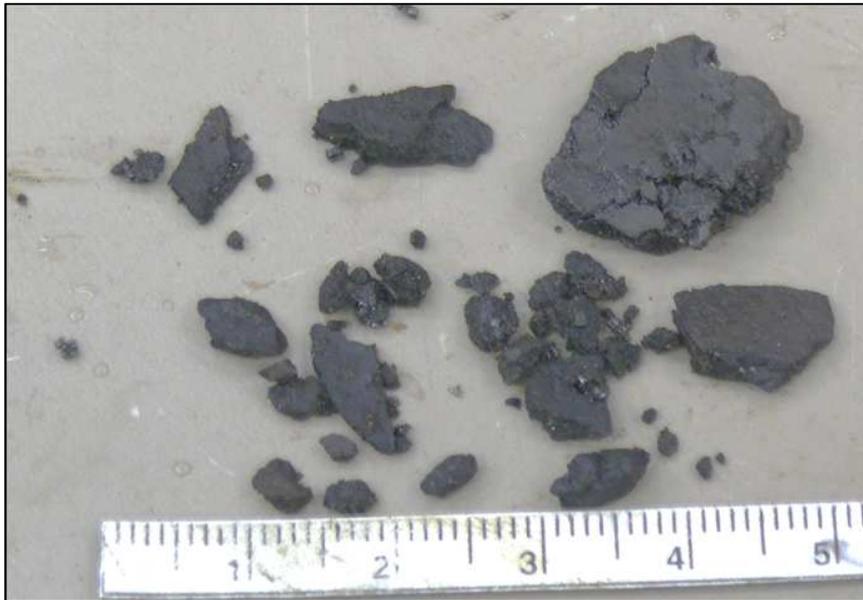
As noted previously in this report, a sample of the oily scale products that were present on the internal surface of the pipe in the buckled zone was collected for chemical analysis. This sample was washed with Varsol to remove the oily residue and is shown in Figure 34. This scale sample was subjected to chemical analysis by x-ray diffraction (XRD), supplemented by energy dispersive x-ray spectroscopy (EDS). The results of the XRD analysis, summarized in Table 4, revealed a high concentration of non-metallic compounds, with silica being the most predominant. Trace amounts of iron-based corrosion products (iron carbonate, iron oxide and iron sulphide) were also detected. The EDS results were in good agreement with the XRD data.

FIGURE 34 SCALE SAMPLE COLLECTED FROM INTERNAL SURFACE OF BUCKLE
