PIPELINE METALLURGICAL FAILURE ANALYSIS

16TAN LICENSE 802177-001

Husky Energy Inc.

October 24, 2016
Acuren Project No.: 306-0087829-1-R1

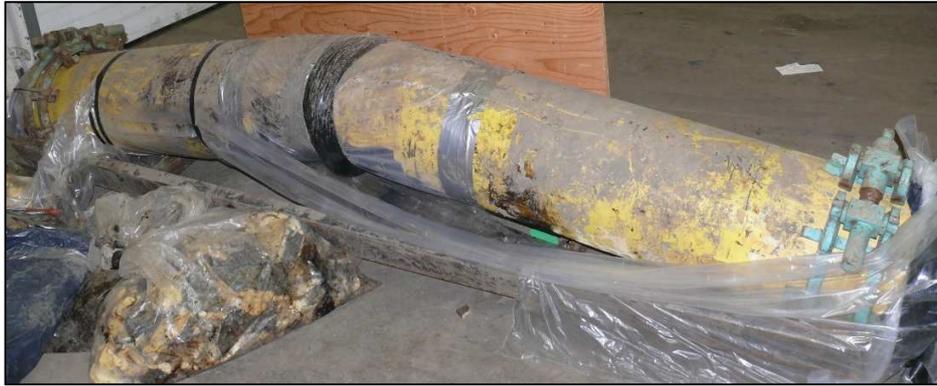
FIGURE 1 AS-RECEIVED PIPELINE FAILURE SAMPLE

A length of steel pipe, shown in Figure 1, was submitted to Acuren. This pipe had been cut from a diluted bitumen pipeline (16TAN, License 802177-001), identified by location as Celtic Junction to East Till Junction (02-32-51-24 to 10-01-50-28 W3M) after a failure was detected on July 21, 2016. The failure location was reported to be adjacent to a river bank at 04-20-51-24 W3M.

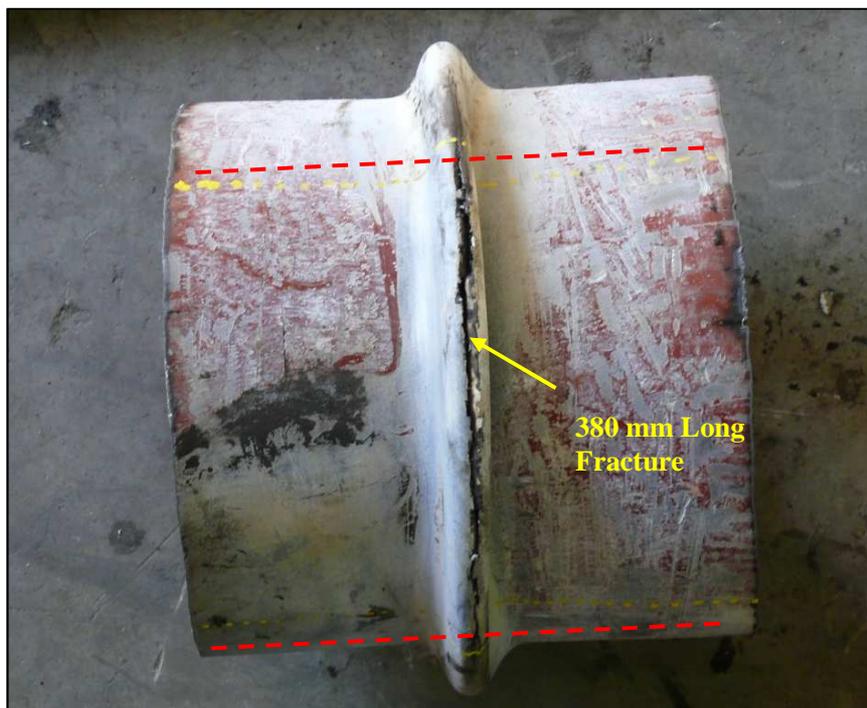
FIGURE 8 LOCATION OF AXIAL SAW CUTS

Axial cuts were made to intersect the two ends of the 380 mm long fracture, resulting in separation of the two through-wall fracture faces and the exposure of the internal surface for more detailed examinations. Figure 8 illustrates the location of the saw cut lines, while Figure 9 shows two views of the separated fractured material in the as-received condition after cutting. A sample of the oily scale deposits that were present on the buckled ID surface was collected for chemical analysis, as described later in this report.

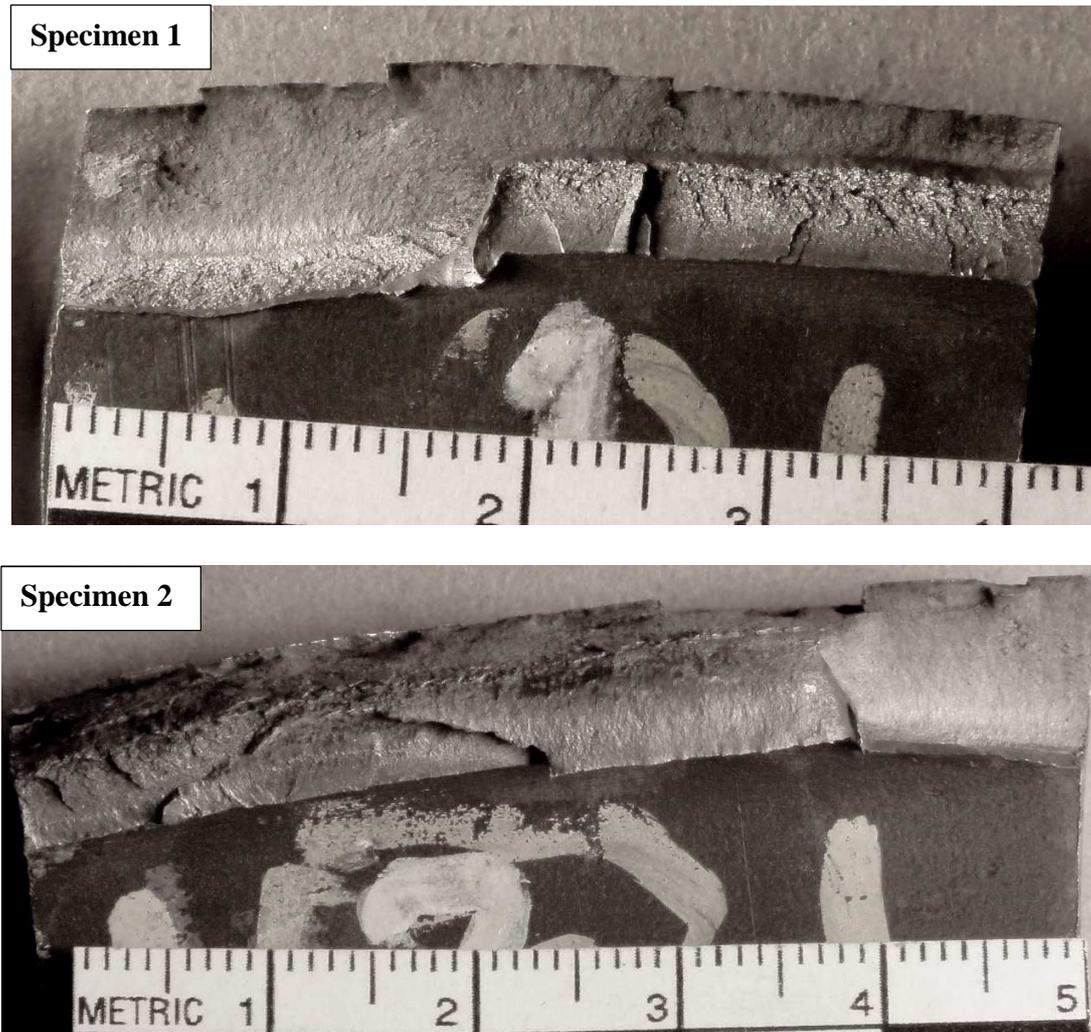
FIGURE 17 CLEANED SEM FRACTURE SPECIMENS

As noted previously in Figures 11 and 12, based on detailed visual examinations of the fracture surface, two locations were selected as being representative of the various fracture features observed. These two specimens were cut from the fracture and ultrasonically cleaned in an Alconox detergent solution. The cleaned specimens (Specimen 1 and 2) are shown in Figure 17.

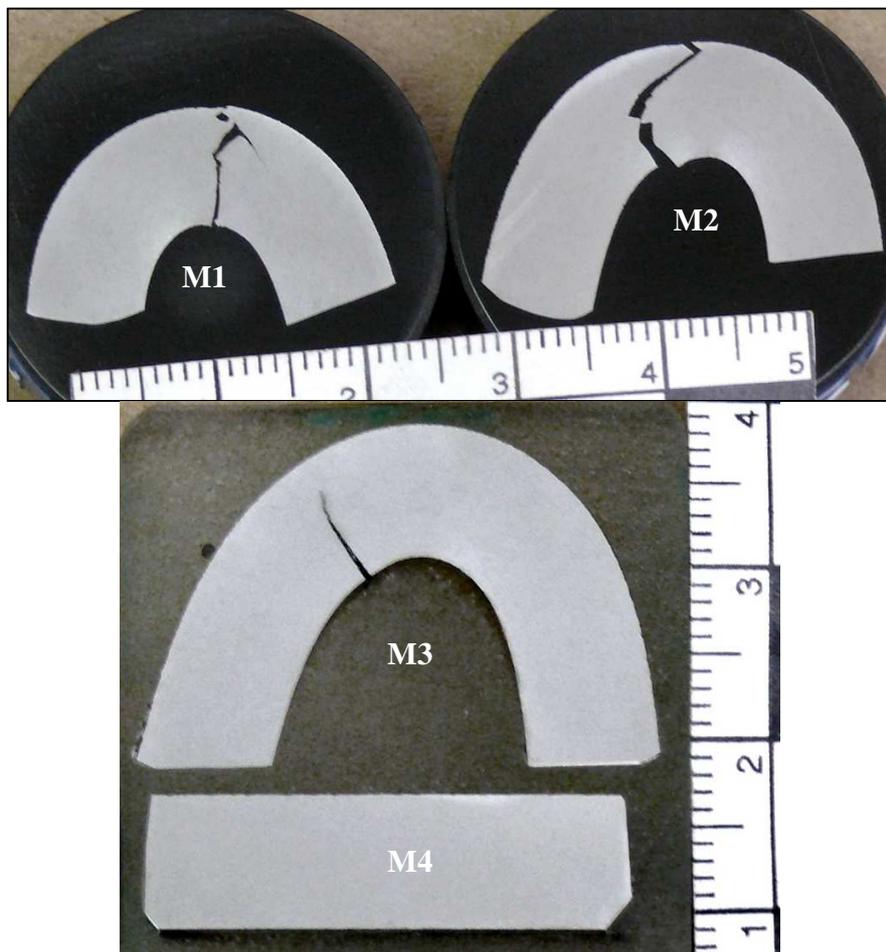
FIGURE 20 PREPARED METALLOGRAPHIC SPECIMENS

Cross sections (M1 and M2) were cut from each of the two SEM specimens through matching locations on either side of the through-wall fracture and prepared for metallographic examination. The fracture locations where these two metallographic specimens were cut from are as noted previously in Figure 12. A third metallographic specimen (M3) was cut and prepared from the intact buckled zone beyond the end of the fracture, where internal cracking was observed (i.e. Fig. 14). For comparison purposes, a fourth specimen (M4) was cut and prepared from the body of the pipe, remote from the buckled zone. The polished and etched specimens are shown in Figure 20.

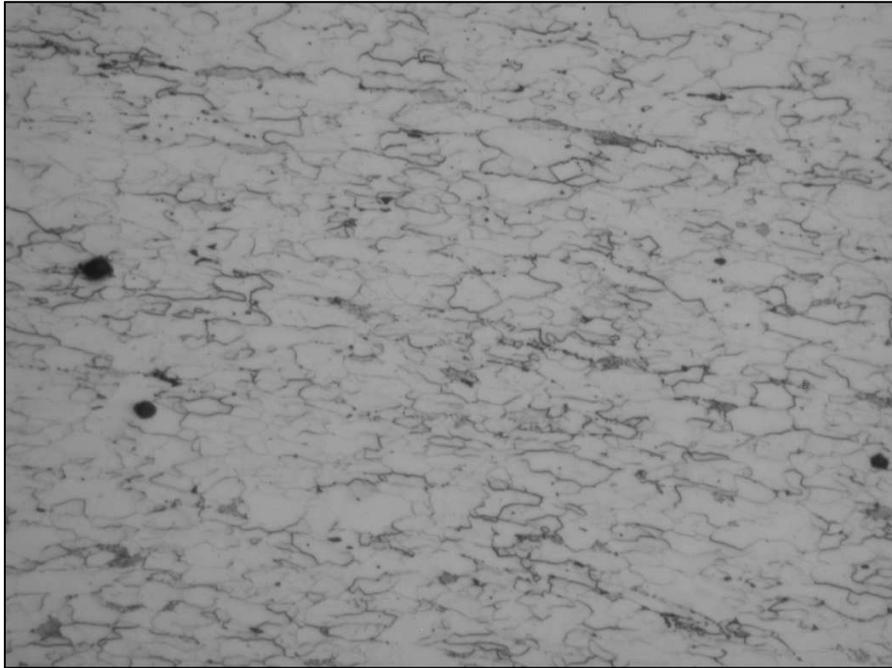
FIGURE 27 TYPICAL MICROSTRUCTURE OF M3 IN BUCKLE MID-WALL ZONE

Figure 25 shows the crack initiation zone at the inner surface of the apex of the buckle in specimen M3, while Figure 26 is a higher magnification image taken at the tip of this brittle crack. The depth of the crack at this location was approximately 6 mm or 75% of the wall thickness. Figure 27 is a high magnification photomicrograph of the typical microstructure observed in the buckled region of M3. The microstructure and brittle crack morphology of M3 were similar to that observed for specimens M1 and M2.

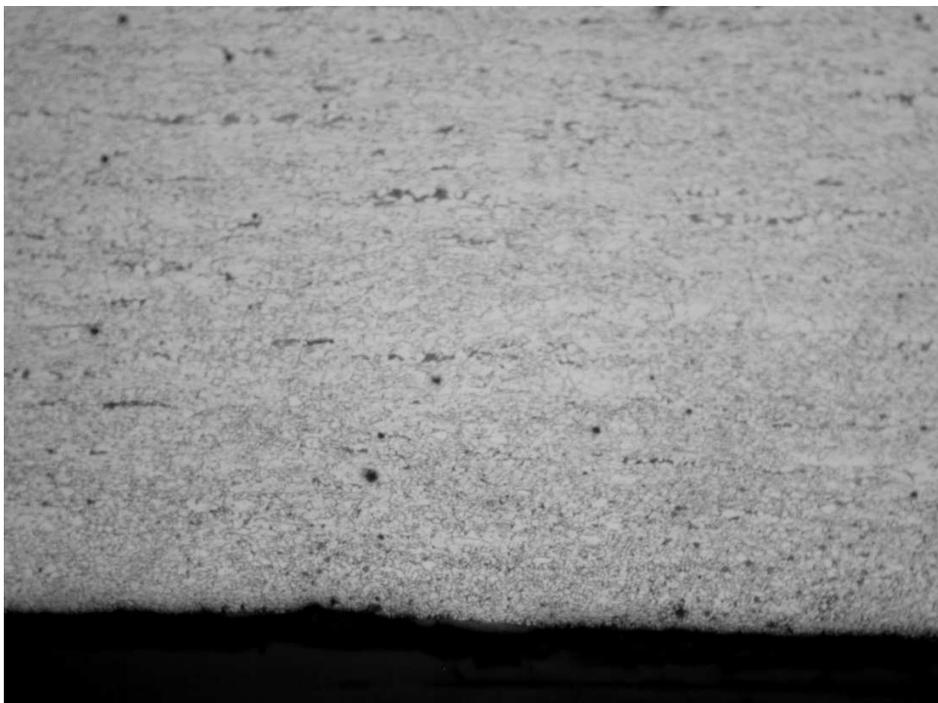
FIGURE 28 PHOTOMICROGRAPH AT ID SURFACE OF M4

Figure 28 is a low magnification photomicrograph of non-buckled specimen M4, taken near the ID surface. Figures 29, 30 and 31 are high magnification images of the typical microstructure taken near the ID surface, mid-wall and OD surface of M4, respectively. The fine-grained ferritic microstructure with isolated pearlite colonies was similar to that observed in specimens M1, M2 and M3. No metallurgical anomalies or defects were observed in this specimen.
